INDOOR AIR QUALITY ASSESSMENT

**Kitteridge Elementary School
601 Main Street
North Andover, Massachusetts**

Prepared by:
Massachusetts Department of Public Health
Bureau of Environmental Health Assessment
June, 2002

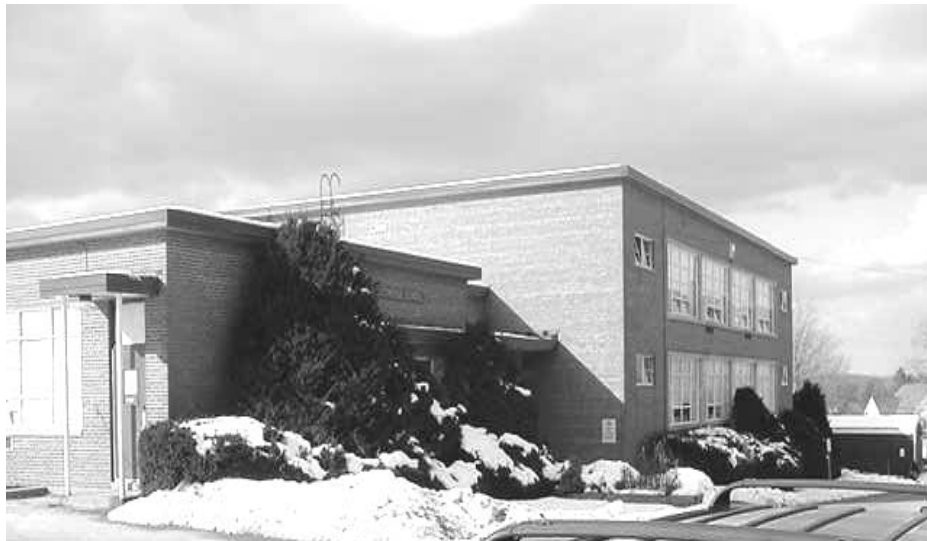
Shrubbery in direct contact with the exterior wall brick was noted along the front of the building (see Pictures 4 and front cover). Shrubbery can serve as a possible source of water impingement on the exterior curtain wall due to plants growing directly against the building. Plants retain water and in some cases can work their way into mortar and brickwork causing cracks and fissures, which may subsequently lead to water penetration and possible mold growth. Each of these conditions allows for the accumulation of water along the base of the building, which can lead to moisture penetration into the basement.

7. Cut back or consider removing shrubbery from the exterior wall of the front of the building.
8. Remove all vegetation from the exterior wall/tarmac seam. Reseal tarmac seams and cracks. Seal the exterior wall/tarmac junction with a water impermeable sealant.

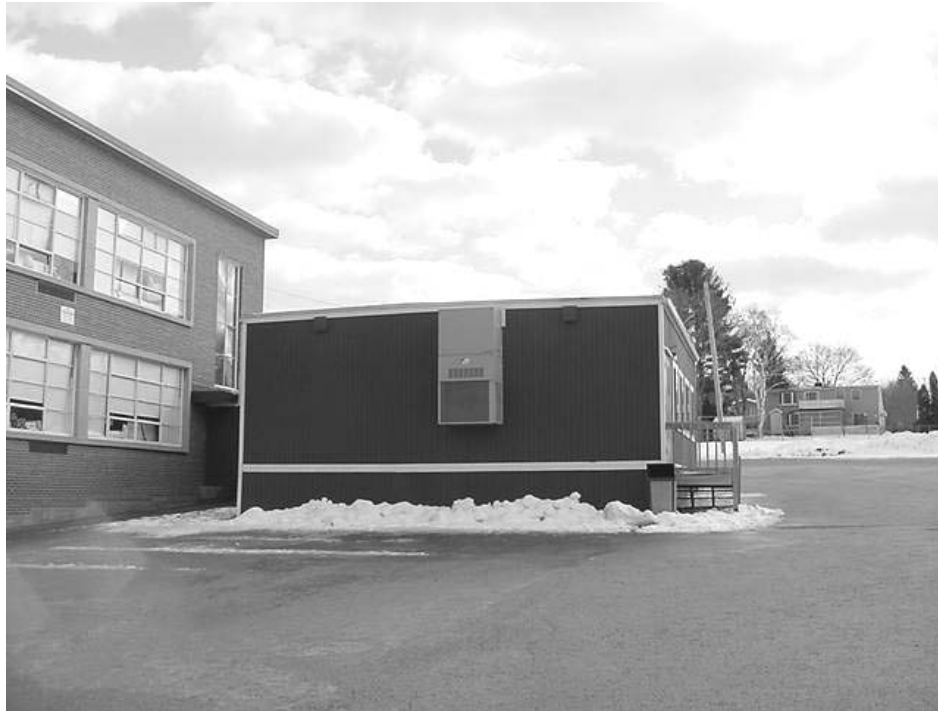
Picture 1

The rear portable classroom has a ventilation system that is separate from the rest of the school. This classroom has ceiling-mounted fresh air diffusers and an exhaust vent, both of which are connected to an air handling unit (AHU) installed on the exterior wall of the modular (see Picture 1). Exhaust air exits through a passive louvered vent by air pressure created by AHU fans as this equipment operates. When the AHU is deactivated, the louvered vent closes. The orientation of the AHU can produce conditions that allow for uncontrolled entrainment of cold air during winter through the passive exhaust vent. The passive exhaust vents face west. Prevailing winter winds are generally northwest (NW). As NW winds blow across the face of the AHU, this airflow can lift the edge of the passive vents and force air in an uncontrolled manner into the return air chamber. In the winter, this condition can introduce cold air that may result in the AHU coils freezing. During warm, humid weather, uncontrolled air introduction can increase condensation inside the AHU cabinet. A thermostat controls the modular AHU with three fan settings: on, off and automatic. The automatic setting on the thermostat activates the AHU system at a preset temperature. Once a preset temperature is reached

in the area of the thermostat, the AHU system is deactivated. On the day of the assessment the thermostat was set to the automatic setting, which had turned off the modular classroom's ventilation system. Modular classrooms are designed to be energy efficient. Therefore little outside air penetration occurs, except when windows are open. The sole supply of fresh air within this room is the ventilation system. Once switched from the automatic setting to the on setting, carbon dioxide levels dropped as fresh air circulated through this room.

The Rear Modular AHU

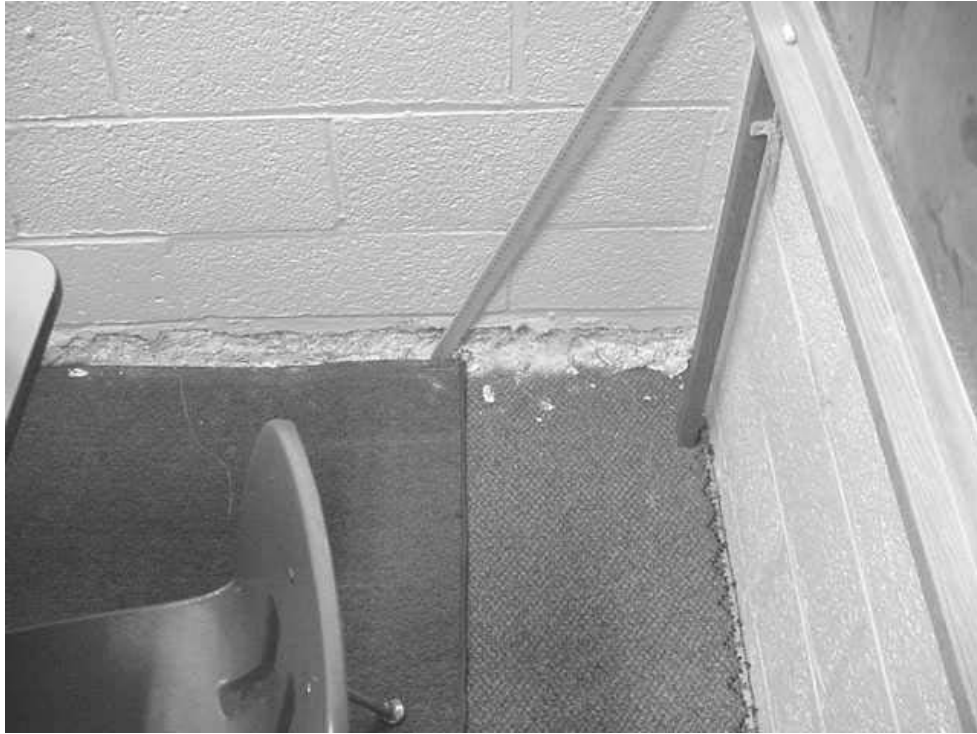
Picture 2

A factor that may be contributing to moisture noted in the basement is water accumulation along the base of the main building. Water stains were noted on the floor near the rear exterior wall of the library on the ground floor. Efflorescence (i.e. mineral deposits) was observed on the brickwork on the interior walls in the guidance room (see Picture 2). Efflorescence is a characteristic sign of water intrusion. As moisture penetrates and works its way through mortar around brick, it leaves behind these characteristic mineral deposits. Efflorescence on carpeting edges and brickwork indicate that these materials have been chronically wetted.

Efflorescence (i.e. Mineral Deposits) Observed on Brickwork of the Interior Walls in the Guidance Room

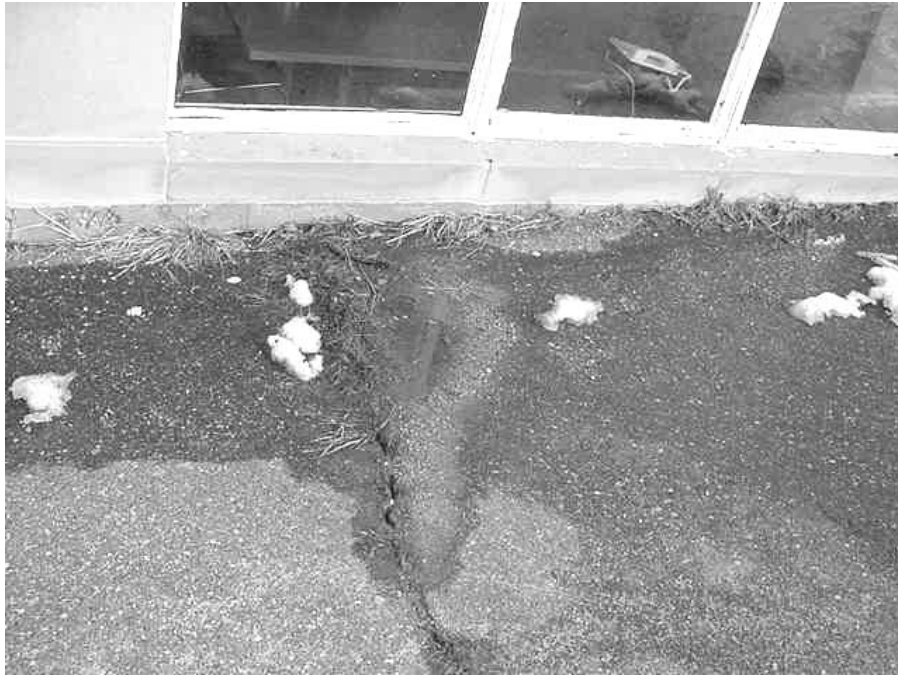
Picture 3

Along the building outside the guidance room, plants were noted growing in the junction between the exterior wall and the tarmac (see Picture 3). Water can gather in the wall/tarmac seam where these plants were observed. Plants collect water that penetrates into the tarmac/exterior wall junction. Freezing and thawing of gathered water can result in damage to the exterior wall, which can result in water penetration into the building.

Plants Noted Growing in the Junction between the Exterior Wall and the Tarmac

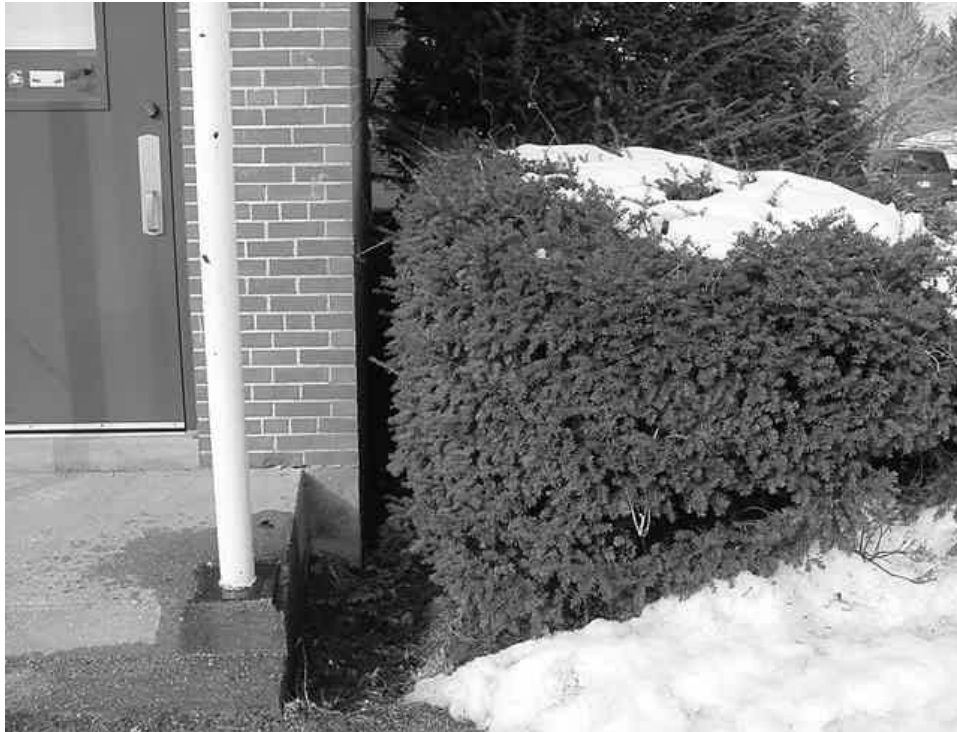
Picture 4

Shrubbery in Contact with Exterior Wall of School

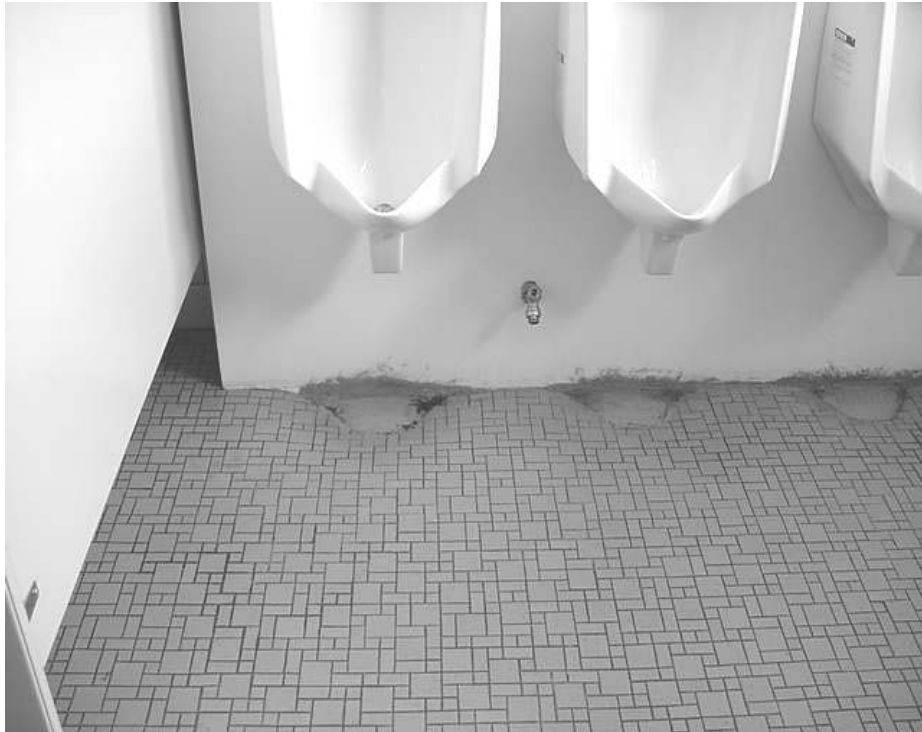
The first floor boy's restroom has urinals installed on gypsum wallboard (GW) (see Picture 5). The original units installed in this restroom were installed in the floor. When the original urinals were removed, a depression was left in the floor underneath the GW. These depressions can accumulate water, which may then wet GW. Chronically moistened GW can grow mold.

**Depressions in Floor of Boy's Restroom Underneath GW;
Note Discoloration of GW Above Floor Depression**

9. Examine the feasibility of repairing the culvert in a manner to provide drainage but eliminate sewer odor production.
10. Remove GW six inches above floor depressions shown in Picture 5 to prevent mold growth. Do not replace GW.

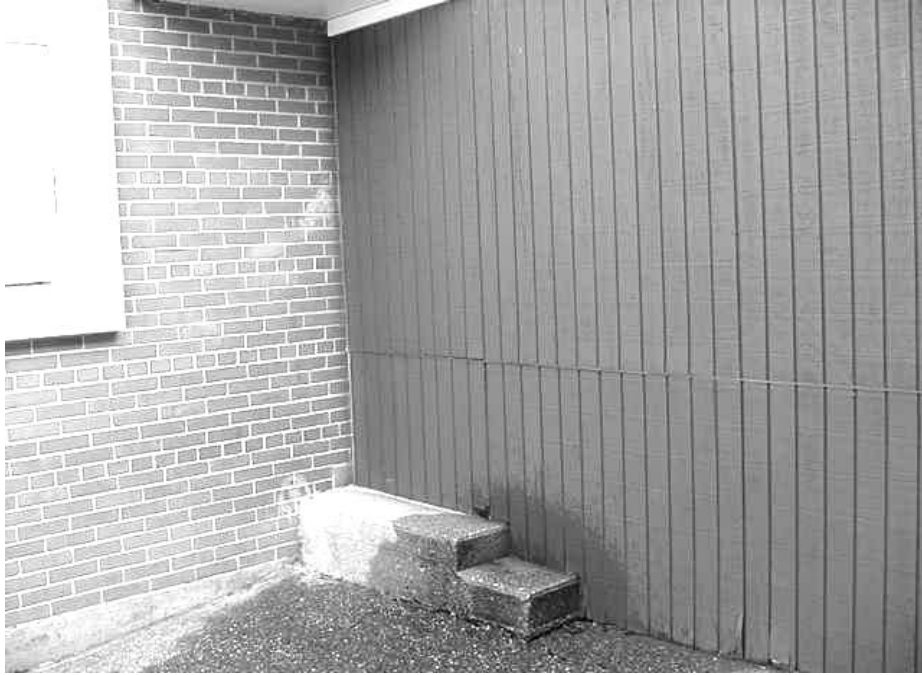
Picture 6

The exterior walls of the rear modular unit appeared to be intact. Drainage for this unit appears to be adequate. No downspout or gutter system exists for this unit, which allows for water on the roof to splash on the tarmac to wet the exterior wall of the modular in several areas (see Picture 6). There are minimal means for ventilating the crawlspace under this structure. Under these circumstances, continued exposure to water to the exterior walls may result in damage to the modular building in the future.

**Wetted Exterior Wall of the Rear Modular
Caused by Water Splashing on the Tarmac Due to a Lack of Gutter/Downspout System**

1. Install downspouts to drain water from the roof and deliver water to the tarmac in a manner to prevent splashing or moistening of the exterior wall.
2. Improve ventilation of crawlspace beneath modular unit by installing large passive air vents. If this is done, ensure that the underflooring is sufficiently insulated.
3. Examine the feasibility of installing a metal awning over the outside of the exhaust vent to limit lifting of the flap by northwesterly winds.
4. Set the thermostat for this classroom to the fan “on” position to operate the ventilation system continuously during the school day.

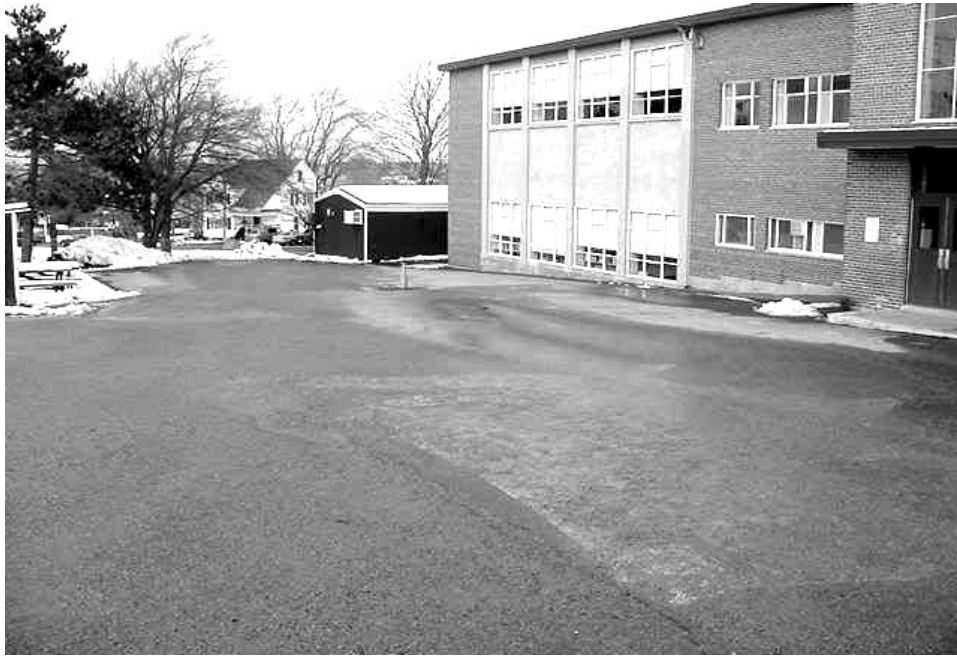
Picture 7

The exterior walls of the modular unit located downhill were in disrepair, with a number of open seams, breaches and other damage. While this unit is located on a slope, the drainage for the tarmac playground behind the school appears to direct groundwater into the rear wall of this structure (see Pictures 7 and 7A). The configuration of this modular unit is the form of the letter “T”, with its base joined to the original building. This configuration creates conditions for snow from the sloped roof to accumulate in contact with the modular unit’s exterior wall (see Picture 8). As snow melts, it wets the exterior wall. No downspout or gutter system exists, allowing water on the roof to splash on the tarmac to wet the exterior wall of the modular in several areas. No means exists for ventilating the crawlspace under this structure. Several of the interior walls of the modular unit located downhill were opened as part of previous assessments. These walls were made of gypsum wallboard covered with vinyl wallpaper. Vinyl wallpaper is a water impermeable barrier, which prevents water evaporation and can lead to microbial growth on GW if water penetrates into the structure. In this case, there appears to be ample opportunity for water to penetrate into the interior of this structure.

Drainage Pattern for the Tarmac Playground Behind the School Appears to Direct Groundwater into the Rear Wall of the Downhill Modular

1. A decision should be made concerning the viability of this structure as occupied space. The water damage and mold growth in floors and walls would militate against repairing these classrooms. Therefore, replacement as recommended by ATC may be the most cost effective measure.
2. BEHA would not recommend reoccupancy of these classrooms unless extensive renovation to remove water-damaged materials and restoring the building envelope integrity is done.
3. Seal the entrance to this area with a sheet of polyethylene plastic and duct tape to prevent odor migration into the stage stairwell.

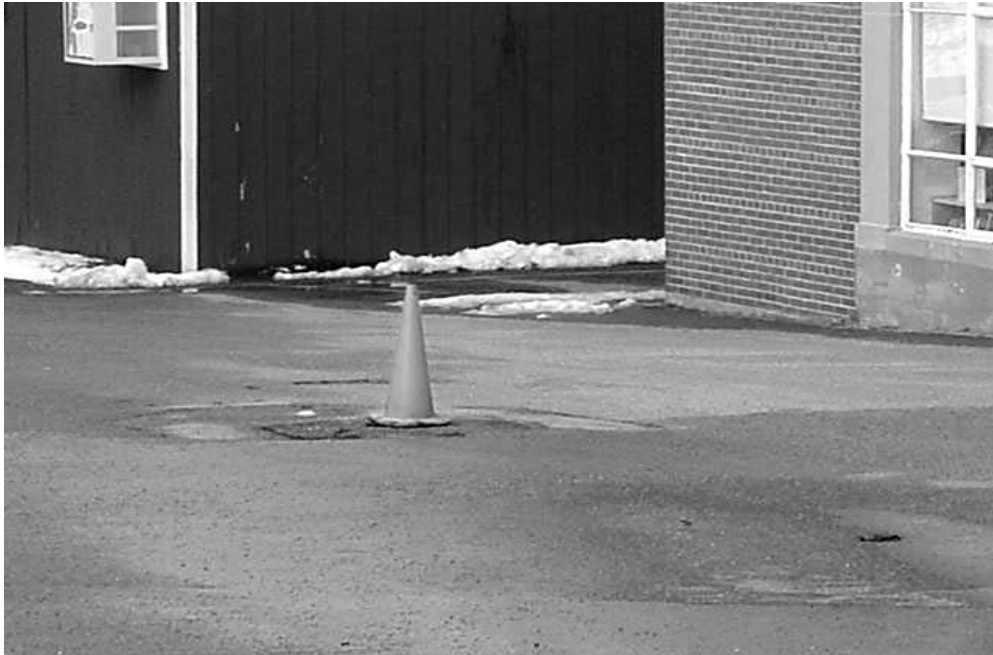
Picture 7A

Close-Up of Drainage Pattern for the Tarmac Playground Behind the School

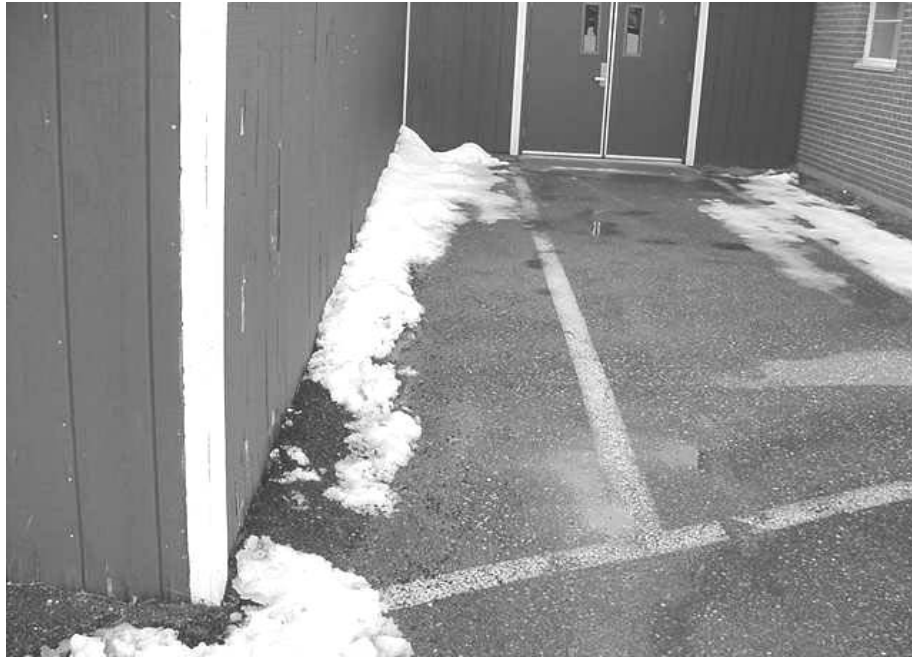
Picture 8

Snow Accumulation against Downhill Modular Exterior Wall

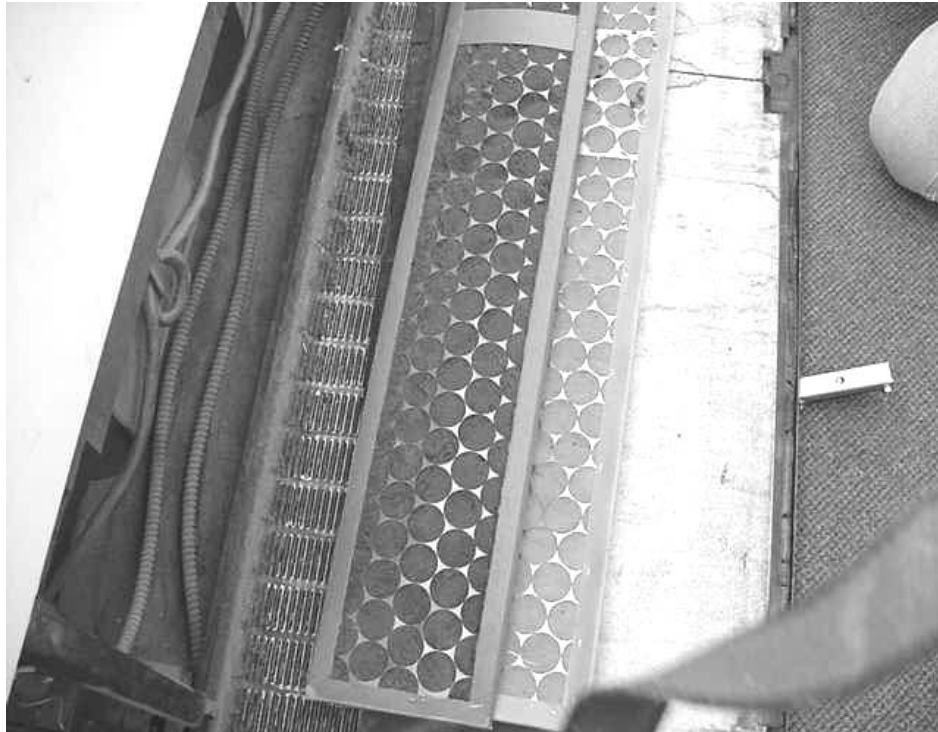
Picture 9

Airflow into the univent is controlled by a pendulum type louver that covers both the fresh air intake and return vents. This configuration requires that two separate filters be installed over the fresh air intake and return vents (see Picture 9). While the return vent filter appeared to be replaced regularly, the fresh air intake vent filter was heavily coated with debris, indicating that it had not been changed. According to school maintenance personnel, the existence of these filters was not known, so no estimate could be made as to the date of the last change. Maintenance staff have since made arrangements to have all second filters of univents changed.

Two Filters within Each Univent, Filter on Left is Recently Replaced

1. Replace the fresh air filter in each univent. Change filters as per the manufacture's instructions or more frequently if necessary.
2. For buildings in New England, periods of low relative humidity during the winter are often unavoidable. Therefore, scrupulous cleaning practices should be adopted to minimize common indoor air contaminants whose irritant effects can be enhanced when the relative humidity is low. To control for dusts, a HEPA filter equipped vacuum cleaner in conjunction with wet wiping of all surfaces is recommended. Drinking water during the day can help ease some symptoms associated with a dry environment (throat and sinus irritations).
